RE: Third Quarter 2009 Inspection Report
Star Point Refuse Pile C/007/042

IMPOUNDMENT INSPECTION AND CERTIFIED REPORT

Report Date October 7, 2009
Permit Number C/007/042
Mine Name Star Point Waste Fuel
Company Name Sunnyside Cogeneration Associates

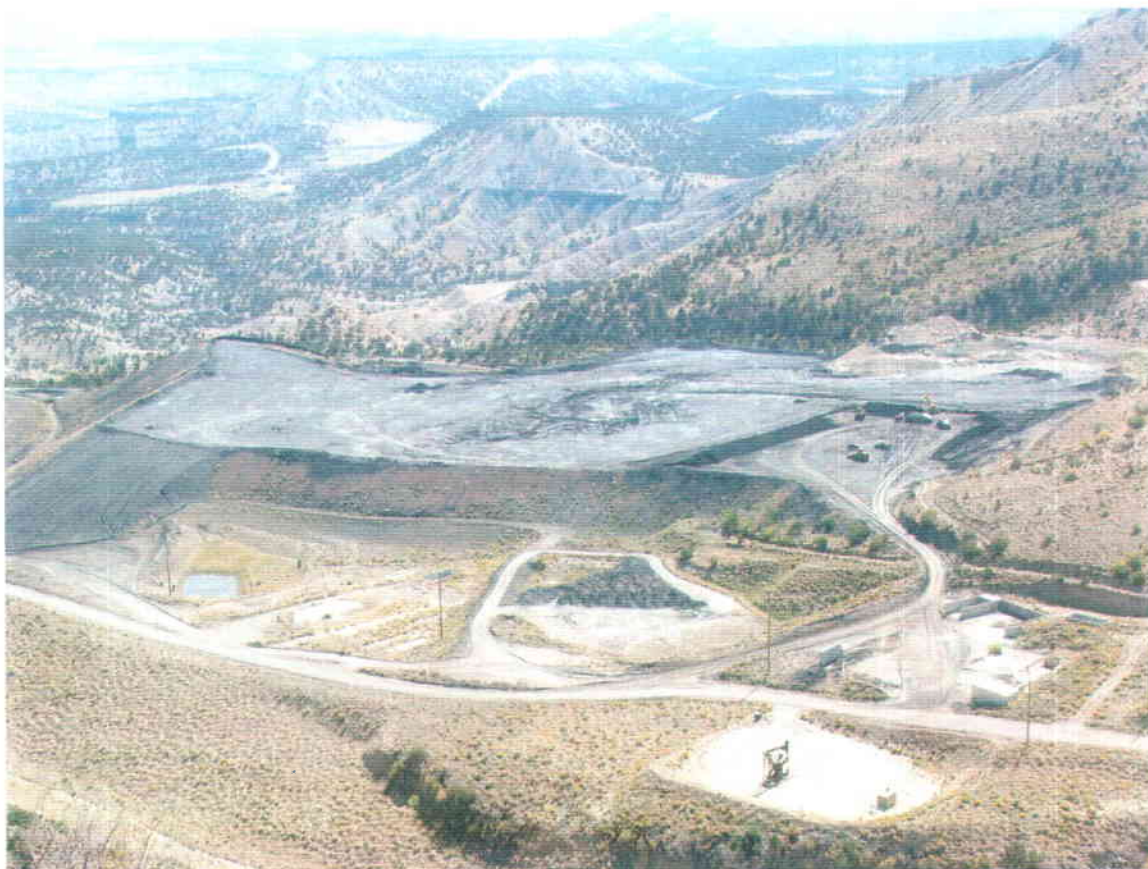
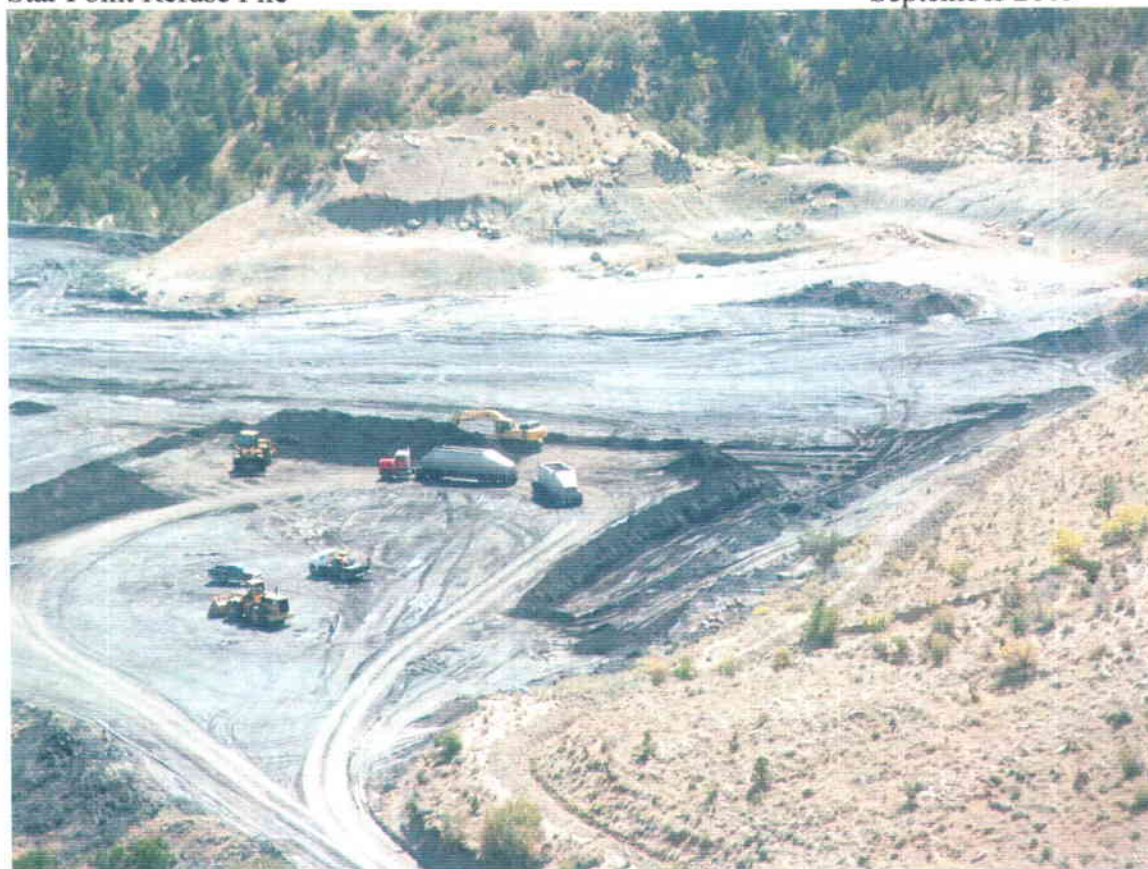
Star Point Refuse Pile

No aspects of the Fill structure were observed that could affect its stability or functionality

Refuse material is actively being excavated and removed from the top of the pile

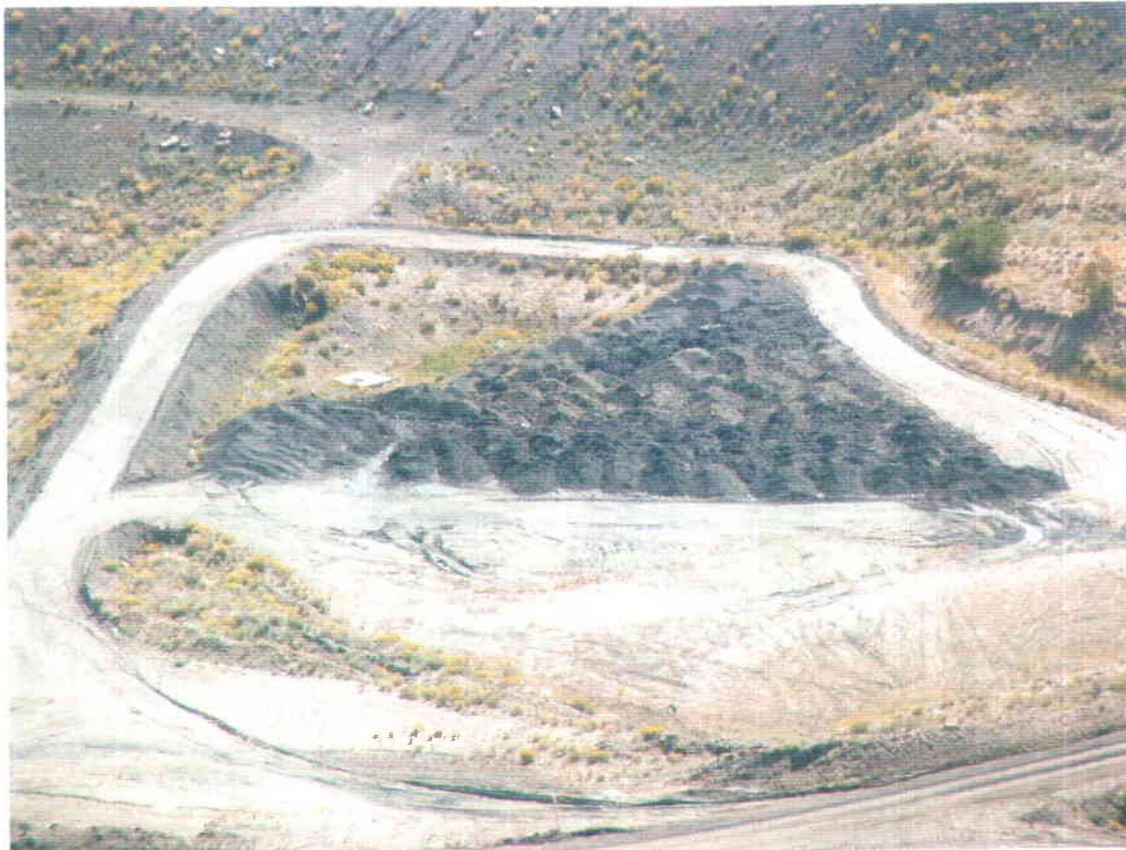
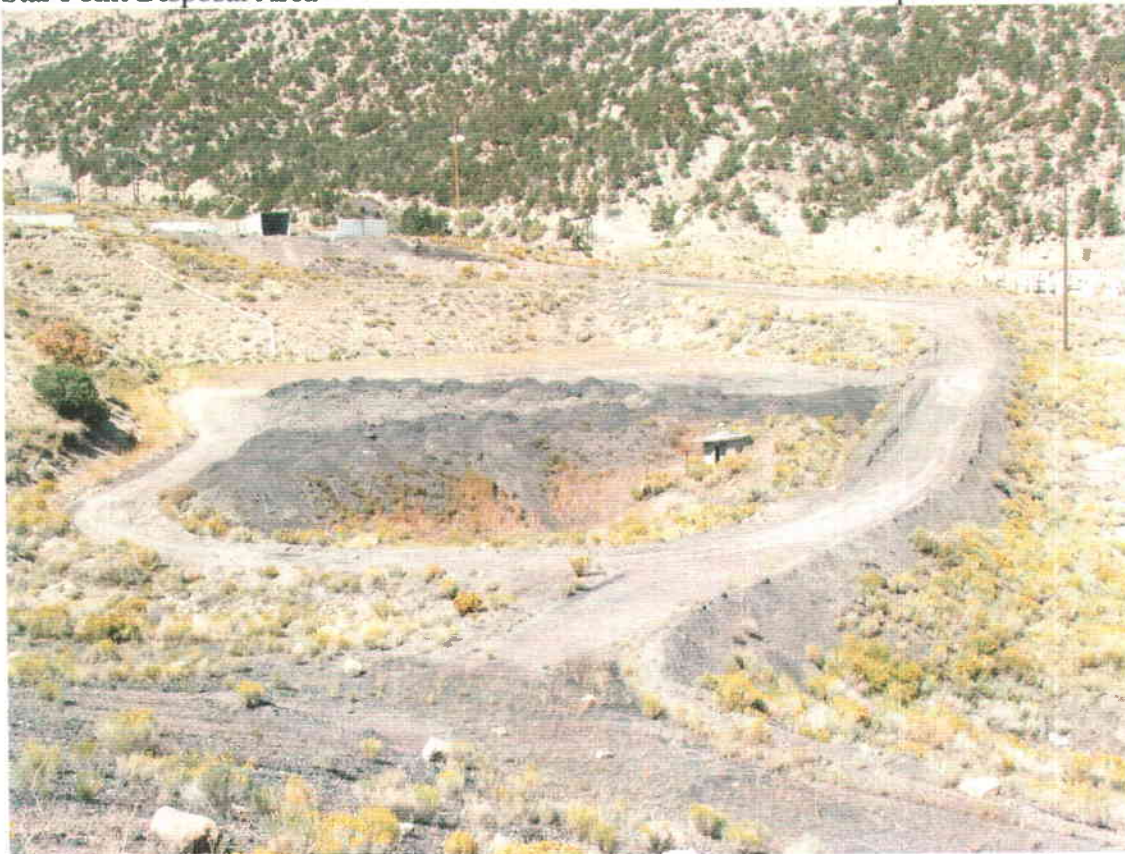
Star Point Disposal Area

The disposal area did not receive any materials during the quarter.

No aspects of the Fill structure were observed that could affect its stability or functionality

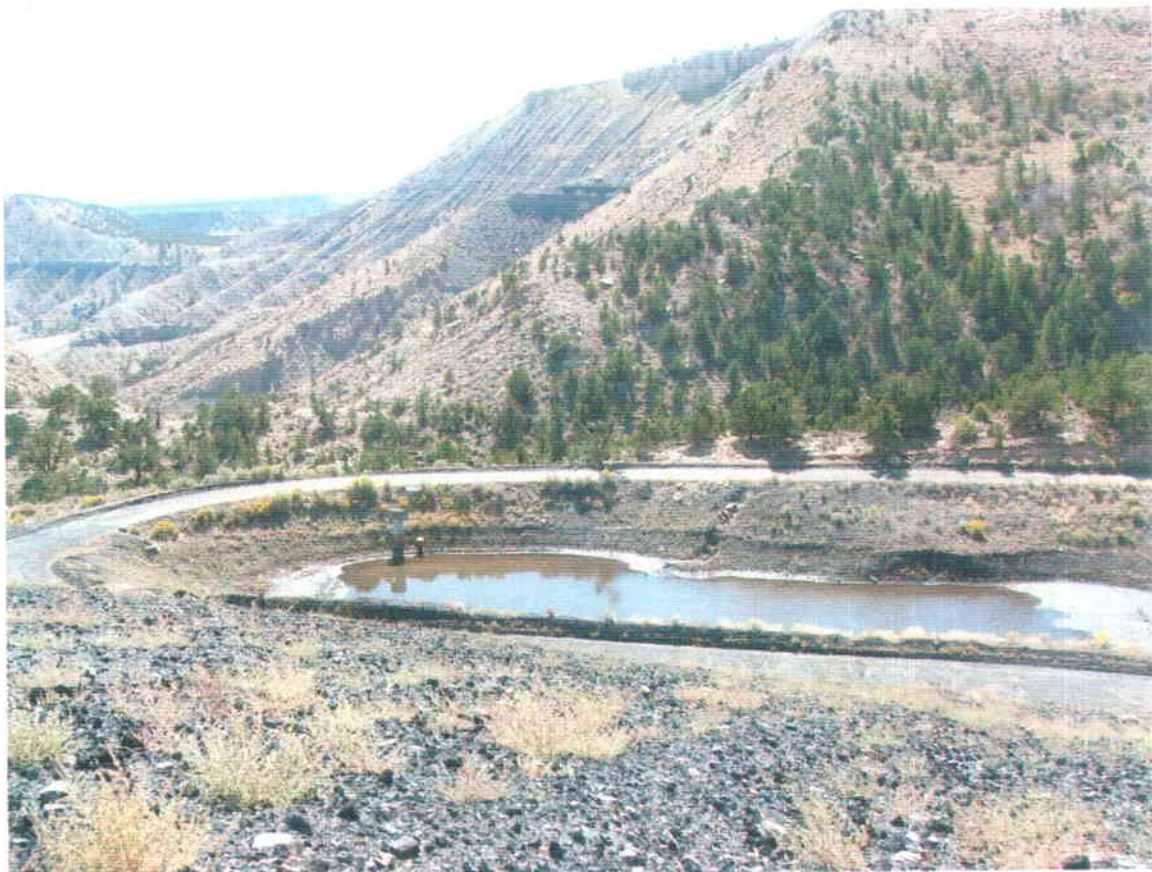
Star Point Sediment Pond #005

Pond had some water in it but was not discharging. No samples were taken
Sediment levels were reasonably low. Pond did not require decanting.
Embankment conditions were good. Vegetation on out slopes was adequate.
Inlet / Outlet conditions were good. No structural or hazardous conditions were observed.

No recent changes in the geometry of the structure have been observed
Depth of impounded water was minimal
Sediment level was good.
No other aspects were observed to affect stability or functionality.

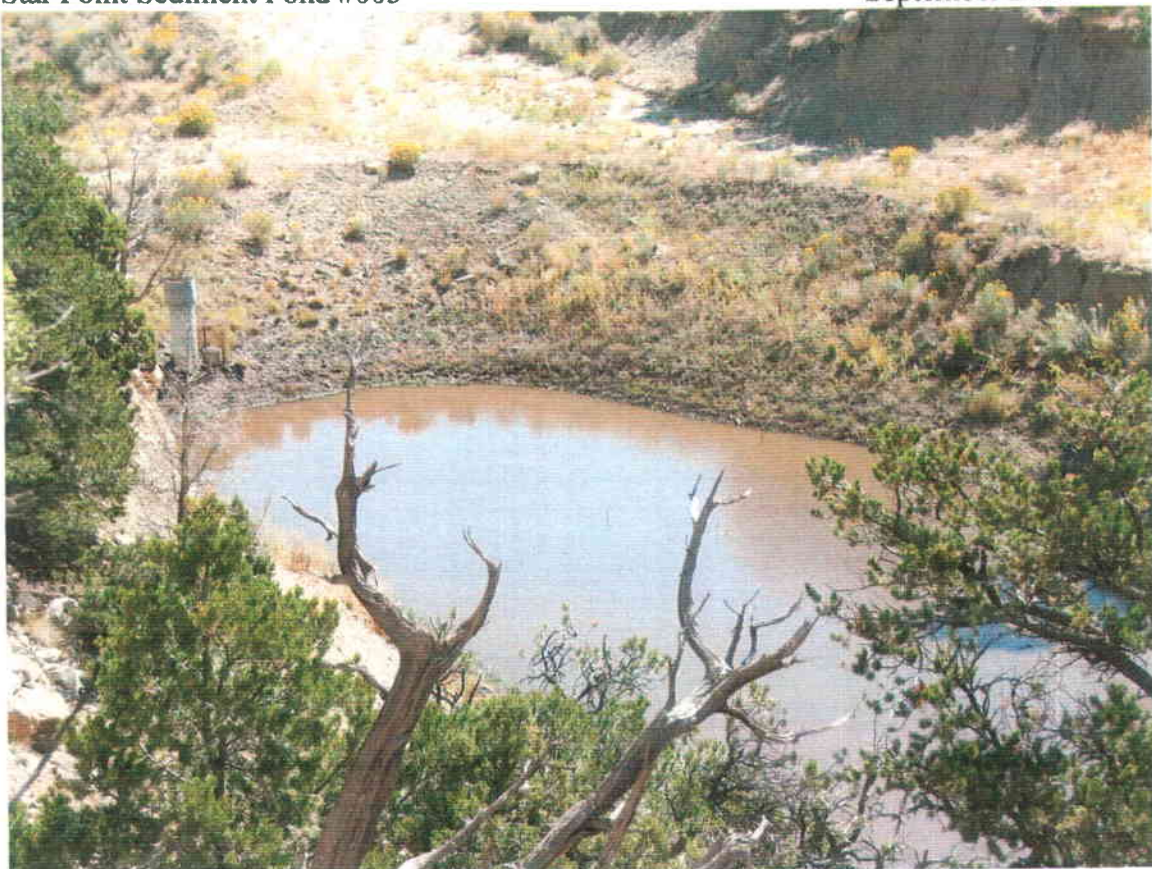
Star Point Sediment Pond #006

Pond had some water in it. No samples were taken
Sediment levels were reasonably low. Pond did not require decanting.
Embankment conditions were good. Vegetation on out slopes was adequate.
Inlet / Outlet conditions were good. No structural or hazardous conditions were observed.

No recent changes in the geometry of the structure have been observed

Depth of impounded water was minimal

Sediment level was good.

No other aspects of the impounding structure were observed that could affect its stability or functionality.
